SANITARY SURVEYS OF THE TOWN OF BLACKSBURG ,VIRGINIA  
AND THE VIRGINIA POLYTECHNIC INSTITUTE

Major Thesis Submitted to the Faculty  
of  
The Virginia Polytechnic Institute  
Department of Biology

June 1937

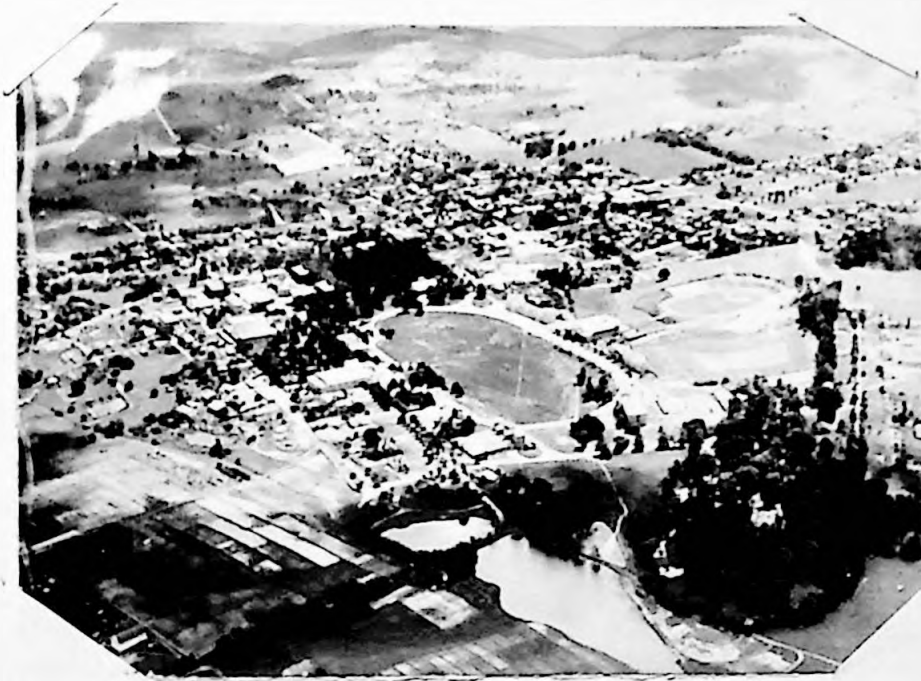
Figure 1

Figure 1. This photograph is an aerial view of the Town of Blacksburg, Virginia and the Campus of the Virginia Polytechnic Institute. (Reduced from a print taken by Capt. Frank Platz, U. S. Army).

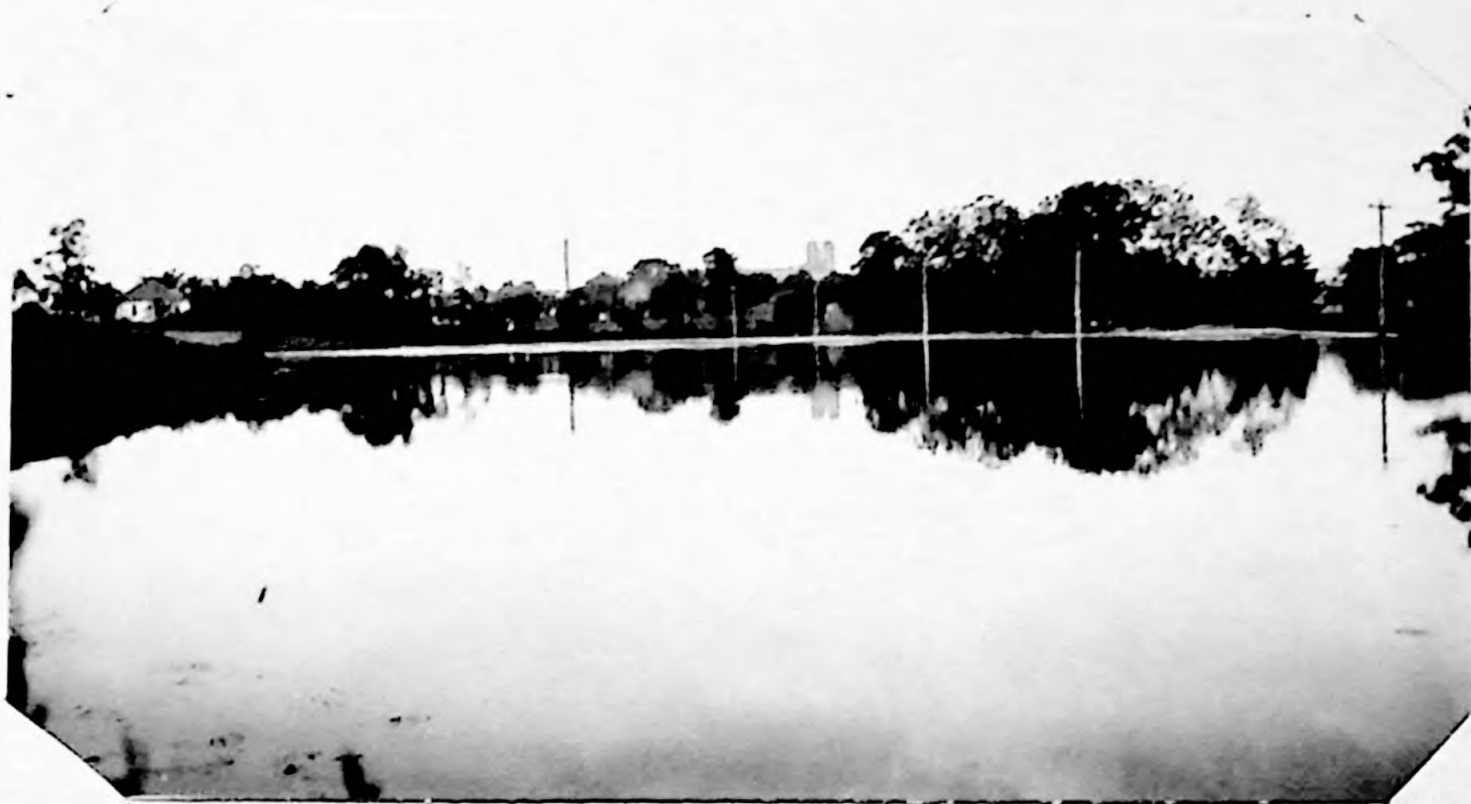
Figure 2

Figure 2. This view shows a portion of one of the reflecting lakes located on the west side of the campus. In the background is seen a part of the Teaching and Administration Building and also a portion of the Power Plant.

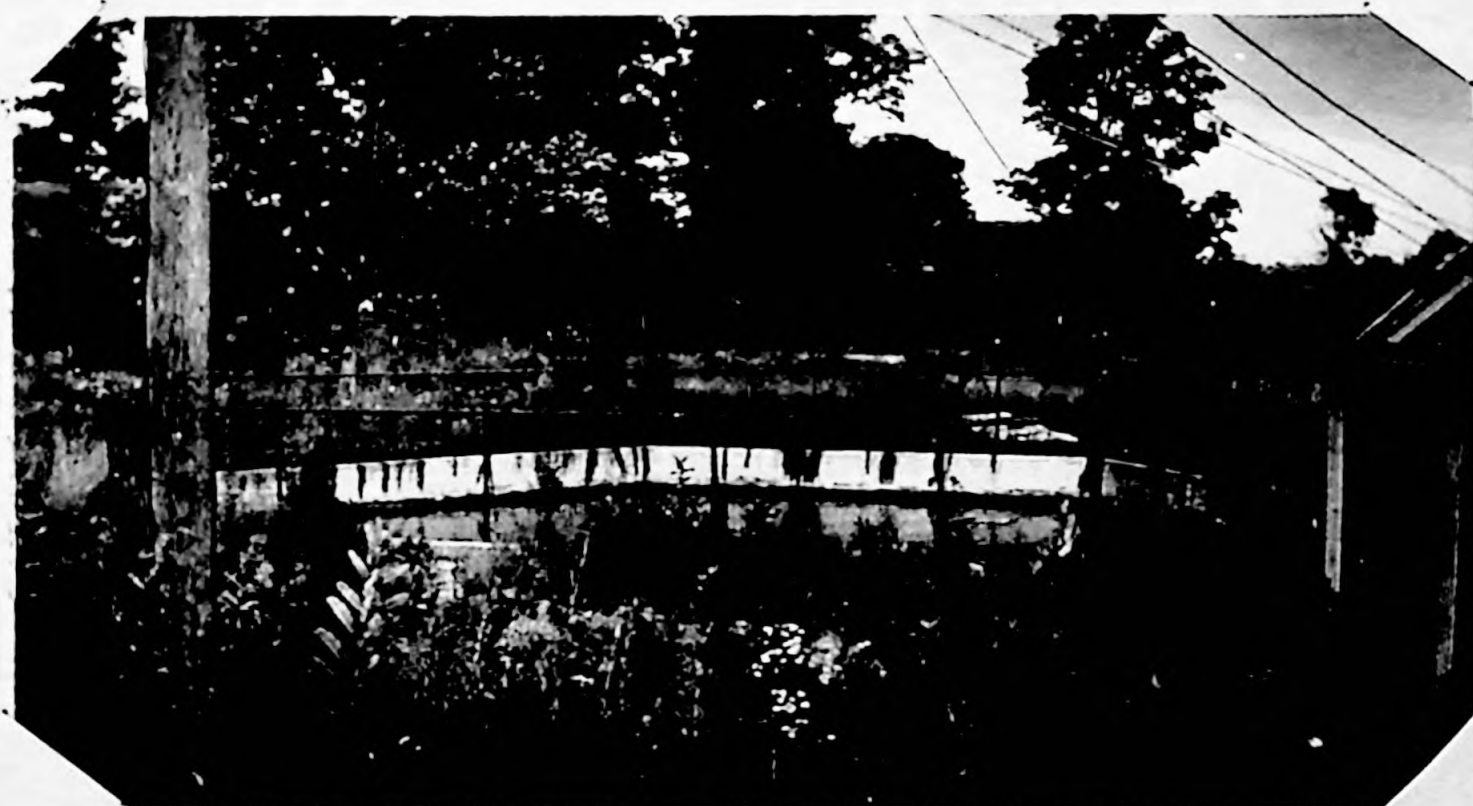
Figure 3

Figure 3. This picture shows a portion of the collecting basin for the college spring. The water flows in this basin and then is chlorinated before being pumped to a sixty thousand-gallon tank near the college barns.

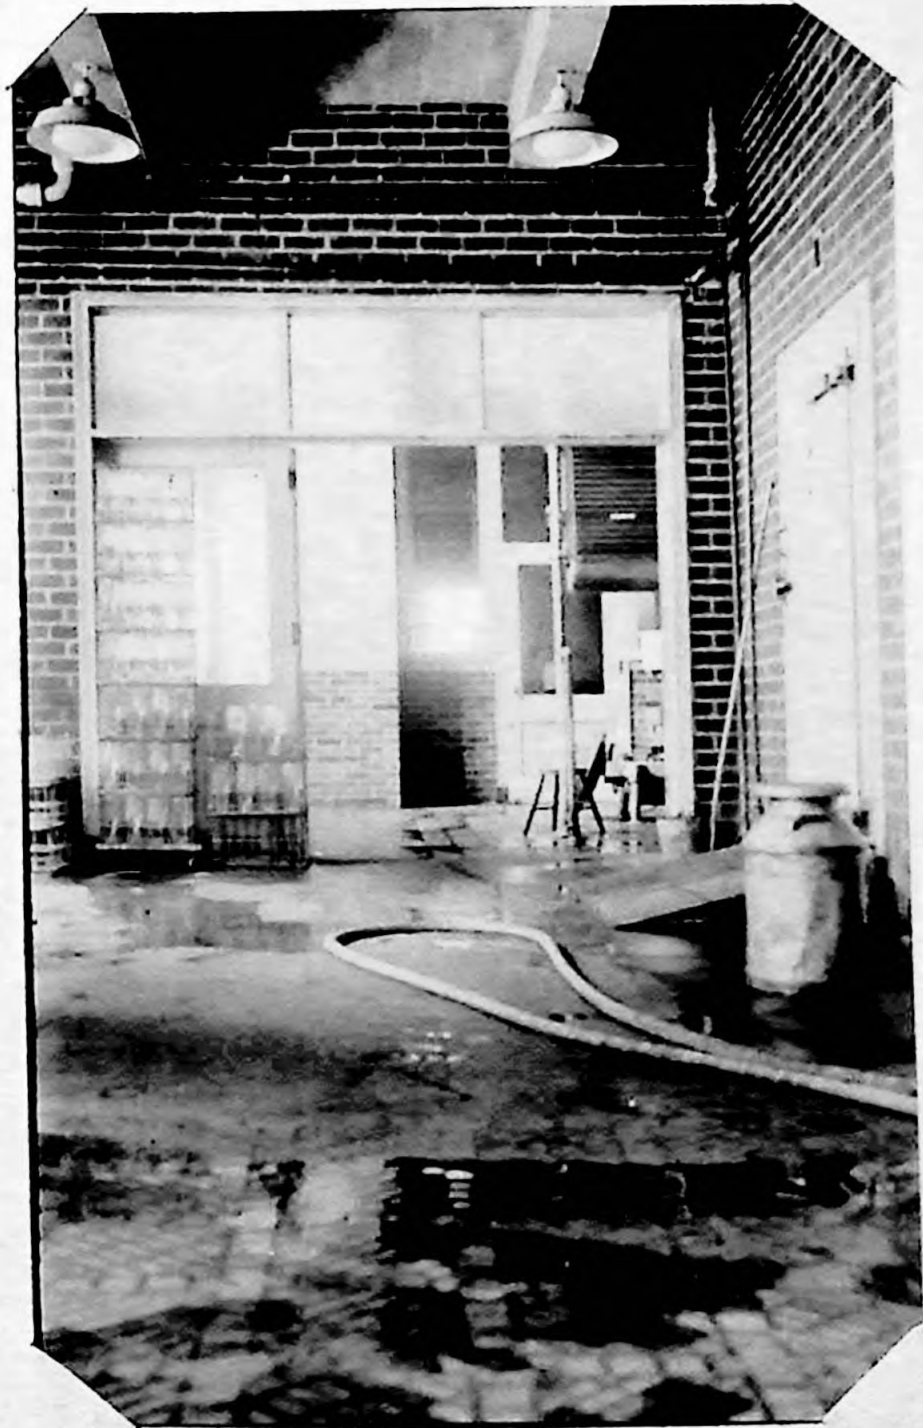
Figure 4

Figure 4. This view shows a portion of the interior of the college creamery.

The college creamery is located in the dairy Husbandry Building on the southwest end of the campus. Milk is conveyed from the college dairy herd to this creamery where it is prepared for the market. At times when the milk supply from the college herd is insufficient, additional milk is purchased from local dairymen, whose herds are free from tuberculosis and Bang's disease.

The milk is pasteurized in a two-hundred gallon pasteurizer by the Holding Method, at 145°F. for thirty minutes. About one hundred and twenty-five gallons per day are pasteurized in this manner, after which the milk is

The ventilation and light are adequate in the creamery. The floors, which are of tile blocks, slant to a central point where waste material is drained. Practically no dust particles exist in the plant. Steam is continuously escaping, and the floors and walls are scrupulously clean.

The creamery is exceptionally clean in every detail, and could be used as a model for the State of Virginia.

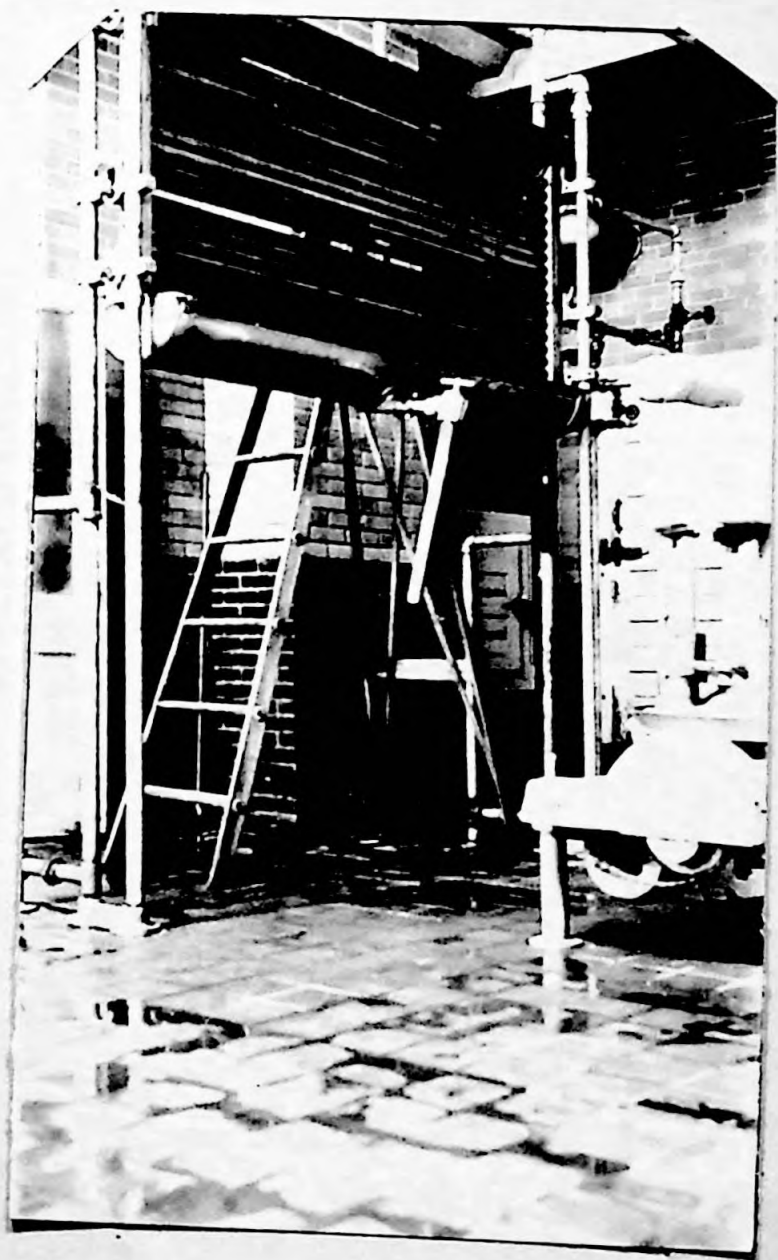
Figure 5

Figure 5. This is also a view of the interior of the college creamery, showing a portion of the milk bottling

machine and cooling apparatus.

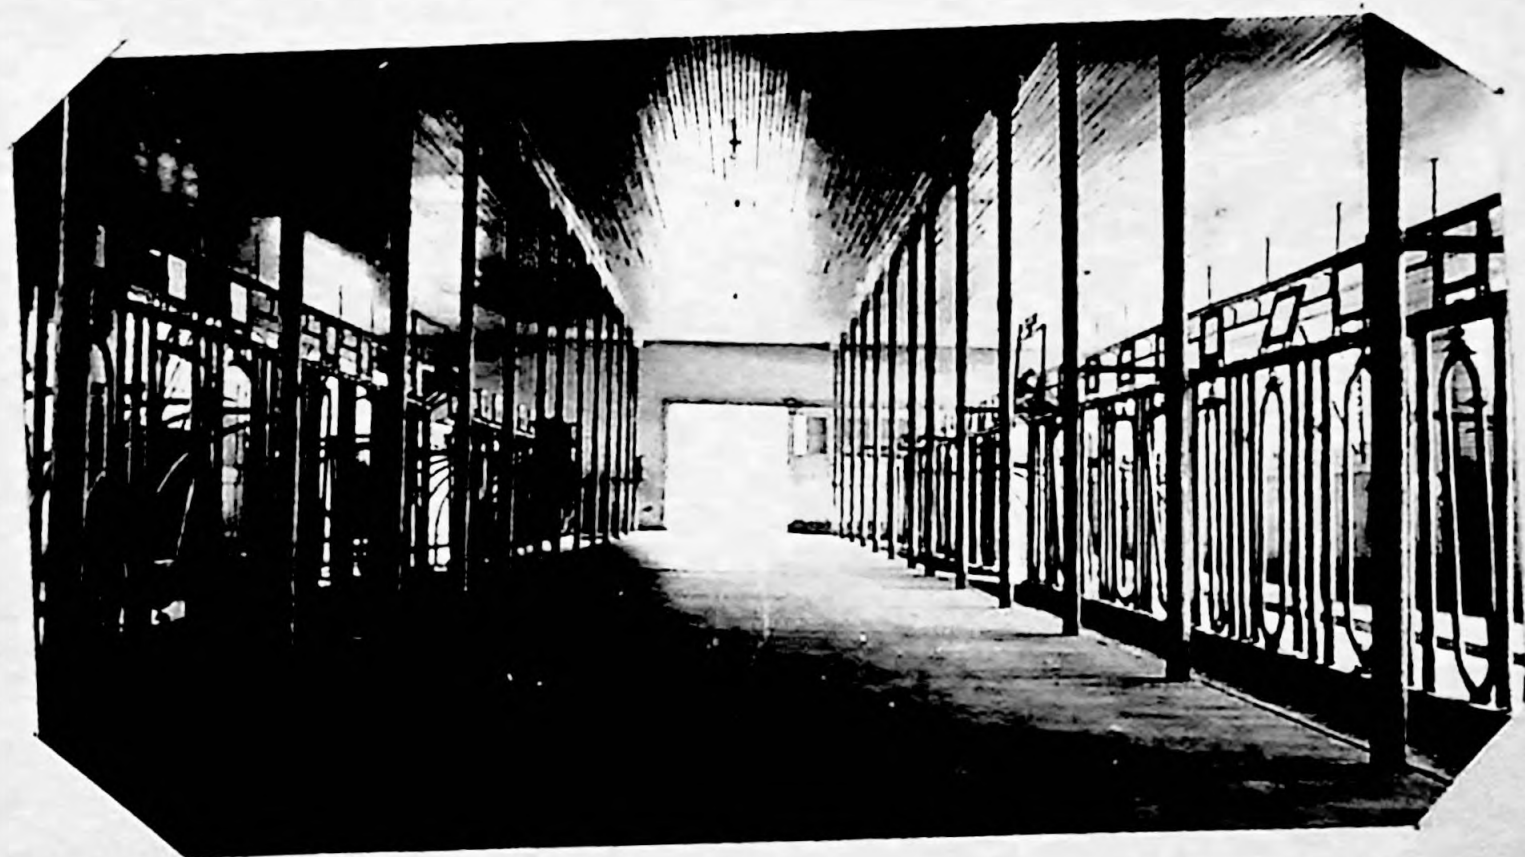
Figure 7

Figure 7. This is a photograph of the interior of one of the college dairy barns. It shows the stances, feeding troughs, and a well lighted room.

There are two Virginia Polytechnic Institute dairy barns. One of these buildings will accommodate seventy-five cows, and the other forty cows. Both buildings are of frame construction with concrete flooring. Ventilation is adequate with plenty of natural and artificial light.
